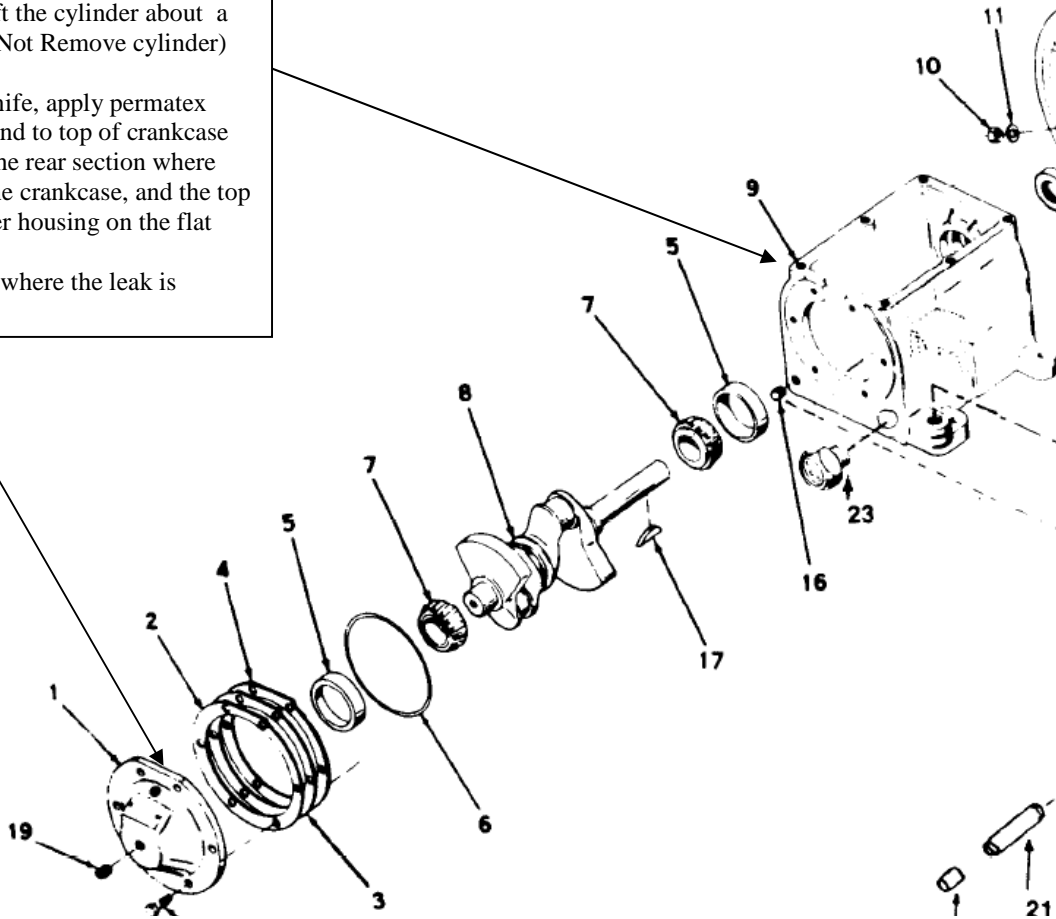
With a putty knife, apply permatex gasket compound to top of crankcase gasket across the rear section where the gap is on the crankcase, and the top of the end cover housing on the flat surface.

This is usually where the leak is coming from.

Loosen the 6 Bolts at the base of the cylinder and lift the cylinder about a half inch. (Do Not Remove cylinder)
